ADVANCED ADHESIVES REPORT

Your corrugating newsletter from Harper/Love Adhesives Corporation

Troubleshooting board crush

The vernier adjustment: friend or foe?

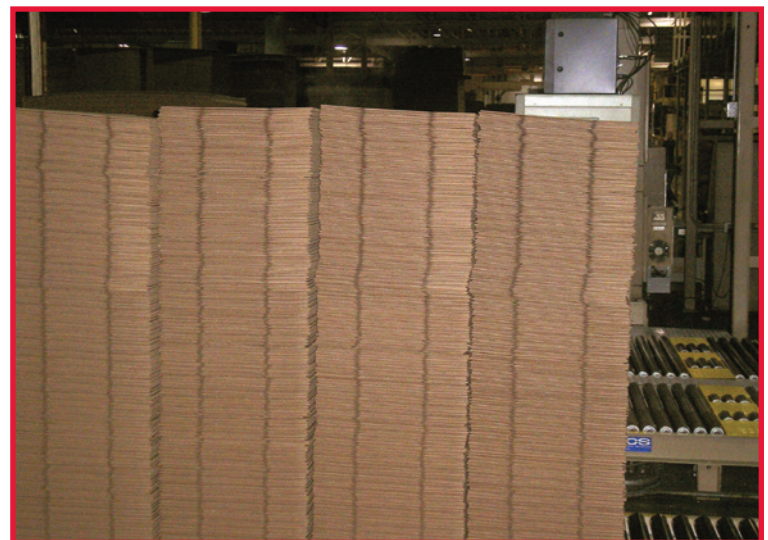
Uneven stacking is evidence of a board crush problem.

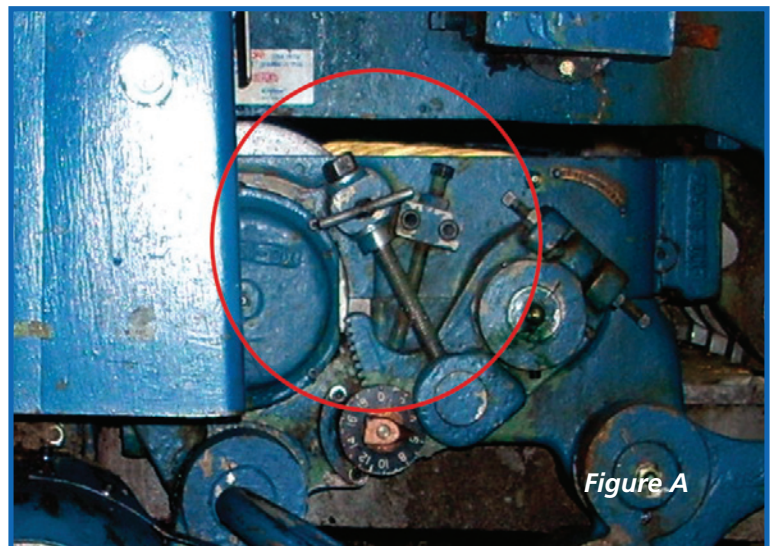
make to control the adhesive application. Figure A shows this adjustment on a Langston XD

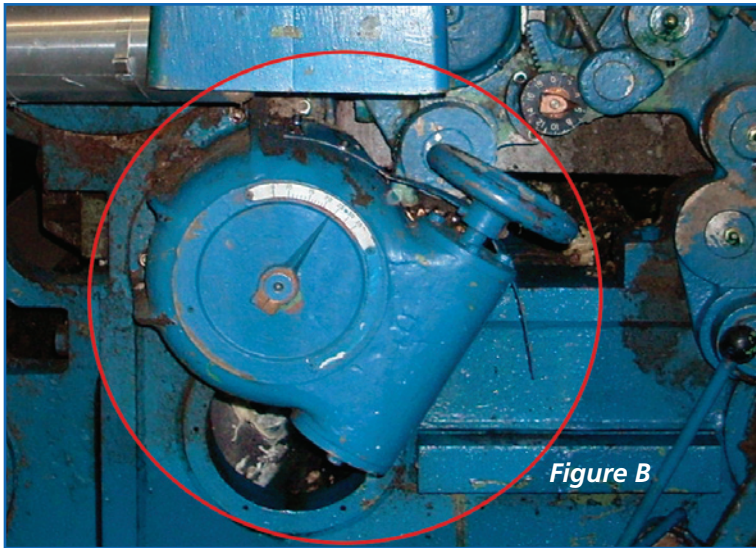
Figure B

The vernier adjustment (Figure B) is not an adhesive adjustment but does affect adhesive application indirectly. Its primary purpose is to control the gap between the glue roll and the lower corrugator roll to accommodate the thickness of the medium being run. To achieve this, the entire glue mechanism is moved in and out of the single facer. Proper adjustment allows the flute tips to dip into the film of adhesive that covers the applicator roll, but without being deformed by the nip between the two rolls. If this gap is too large for the medium being run, operators tend to compensate by increasing the glue roll to metering roll gap (and thus the adhesive film thickness). This causes a loss of control of the application and generally wastes adhesive since the adhesive is not being placed accurately on the flute tips.

The second part of the modification involves simply removing or disabling the vernier adjustment and locking the mechanism so it can't move and throw the rolls out of parallel.

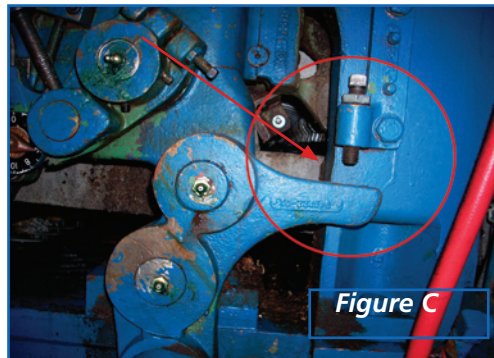
It is not unusual for this mechanism to wear out and not work properly, sometimes throwing the glue mechanism out of parallel with the corrugating rolls in the process. Because of this, operators sometimes resort to adjusting the machine at the paralleling mechanism using the mechanical stop bolts (Figure C). This adjustment point is also the mechanical stop. So although it is an effective alternative, there is a real risk of misadjusting them and having the glue roll crash into the lower corrugating roll, possibly damaging both.

It is possible to make a modification to the machine which addresses these problems. The basic concept is to place a moveable shim (Figure D) between the stop bolt and the arm. The machine is adjusted to run thin to regular medium (say 23 lbs to 26 lbs per MSF) without the shims in place. Then, when the crew needs to run heavy medium (say 40 lbs or Dual Arch), the shims are moved into place. This eliminates the need to move the paralleling adjustment at the mechanical stops and is much quicker and more accurate. The red arrow in the Figure C shows where these shims would be placed on an XD.

Below, modifying the machine for quick, convenient, and repeatable changes in the glue gap adjustment: A flat shim under the glue roll stop adjusting screw may drop out when the machine is stopped and the glue roll mechanism retracts. A shim formed into a channel shape can be clipped onto the lever arm and will stay in place.

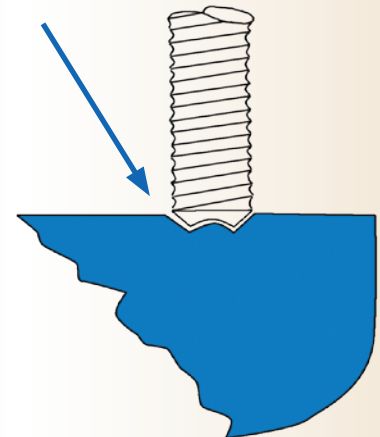
On Langston XDs, the glue roll stop screws, which control the glue gap and roll parallelism, should be flat bottomed. If these screws have been replaced with dog-point set screws, they can cut into the lever arm (or the suggested shims, above), creating burrs and an unreliable stop. The burrs on the lever arm should be removed, and the screw replaced with a flat-bottom type, or simply reversed so the head bears on the lever arm.
